HRL 2018 look & feel verification report for Imperviousness (2018) Norway

I. Administrative part

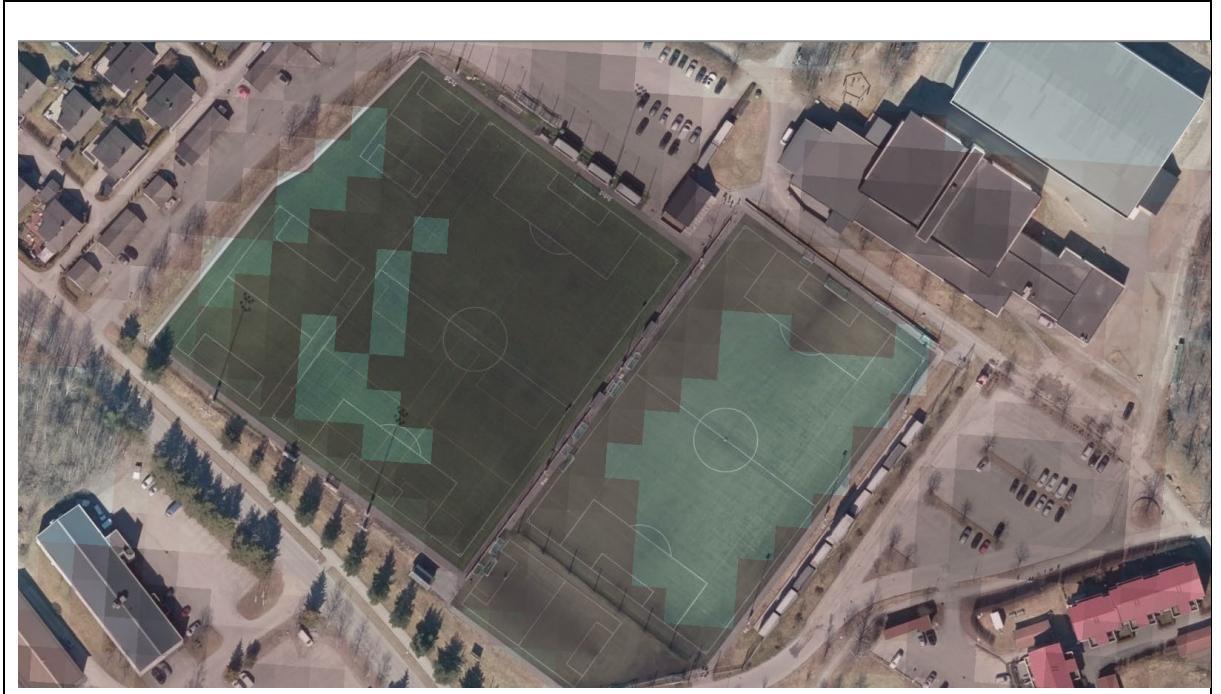
Soccer fields and tennis court confirmed as artificial grass partly rendered as impervious [ETRS1989 LAEA: 43477200, 4190000]

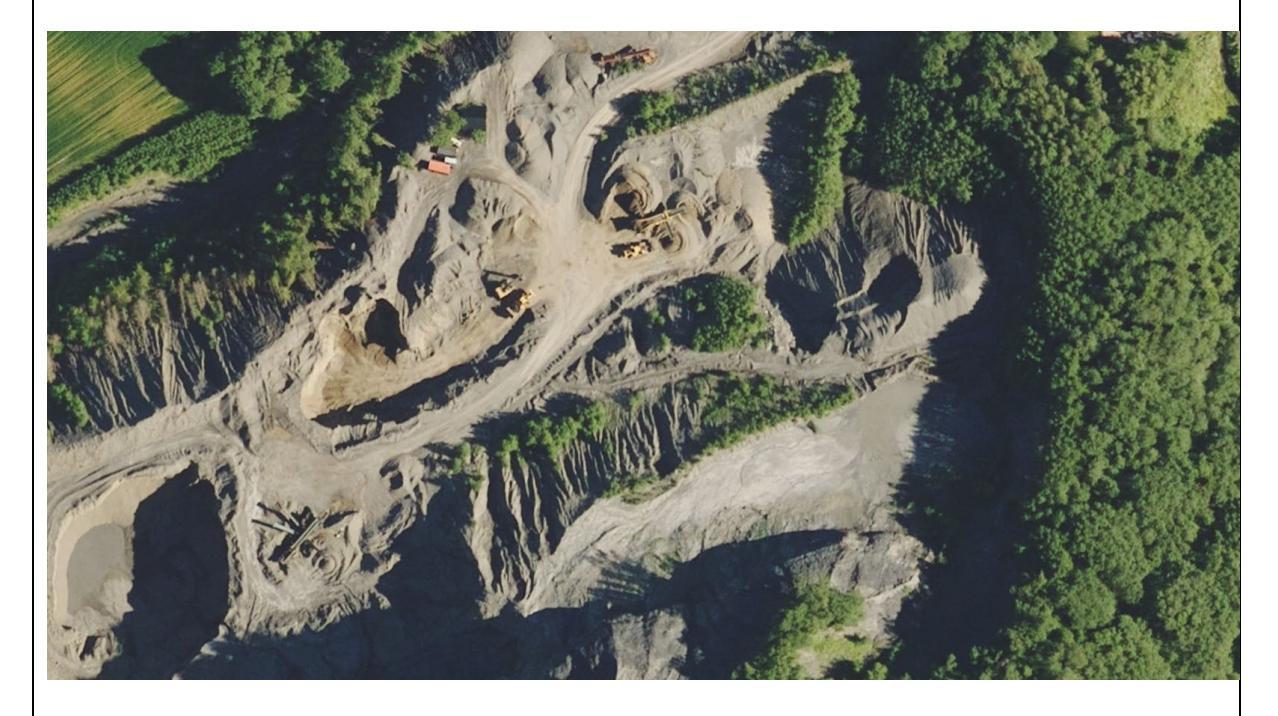
Gravel extraction site. Part of this extraction site was wrongly mapped as impervious in 2015. The entire (and enlarged) site is correctly mapped as not impervious in 2018. [ETRS1989 LAEA: 4404900, 4519325]

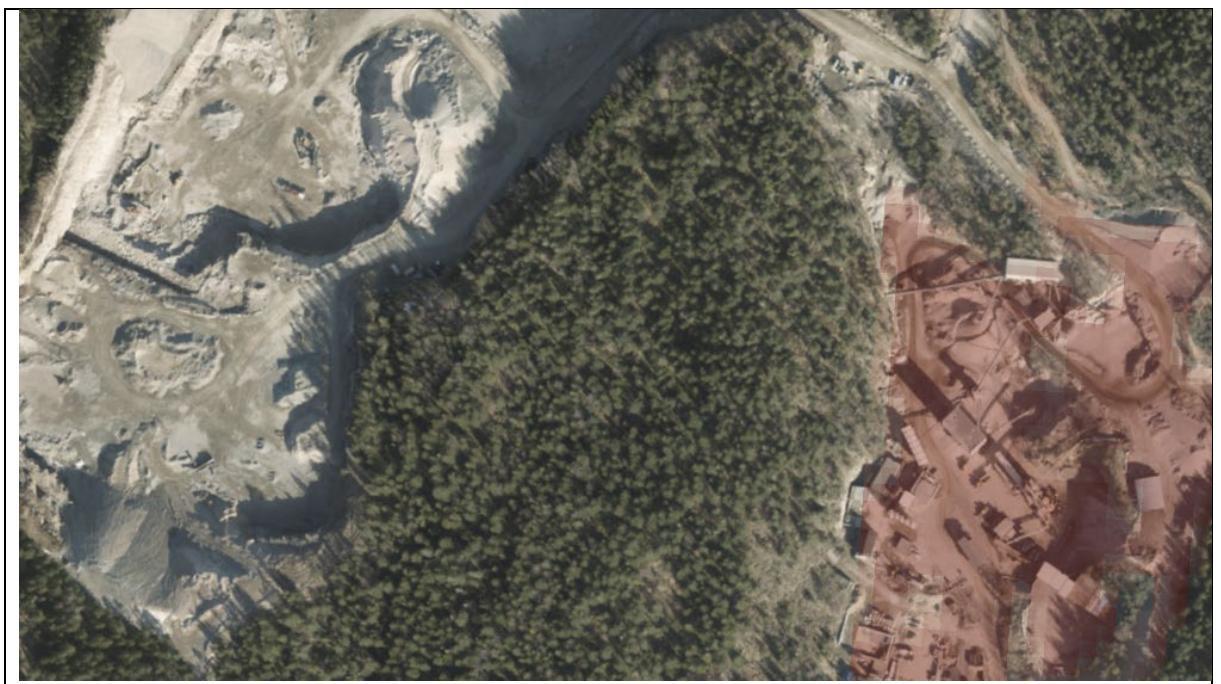
The quarry to the left is correctly not classified as impervious while the post-processing to the right is partially not correctly classified as imperivous. [ETRS1989 LAEA: 4372900, 4097900]

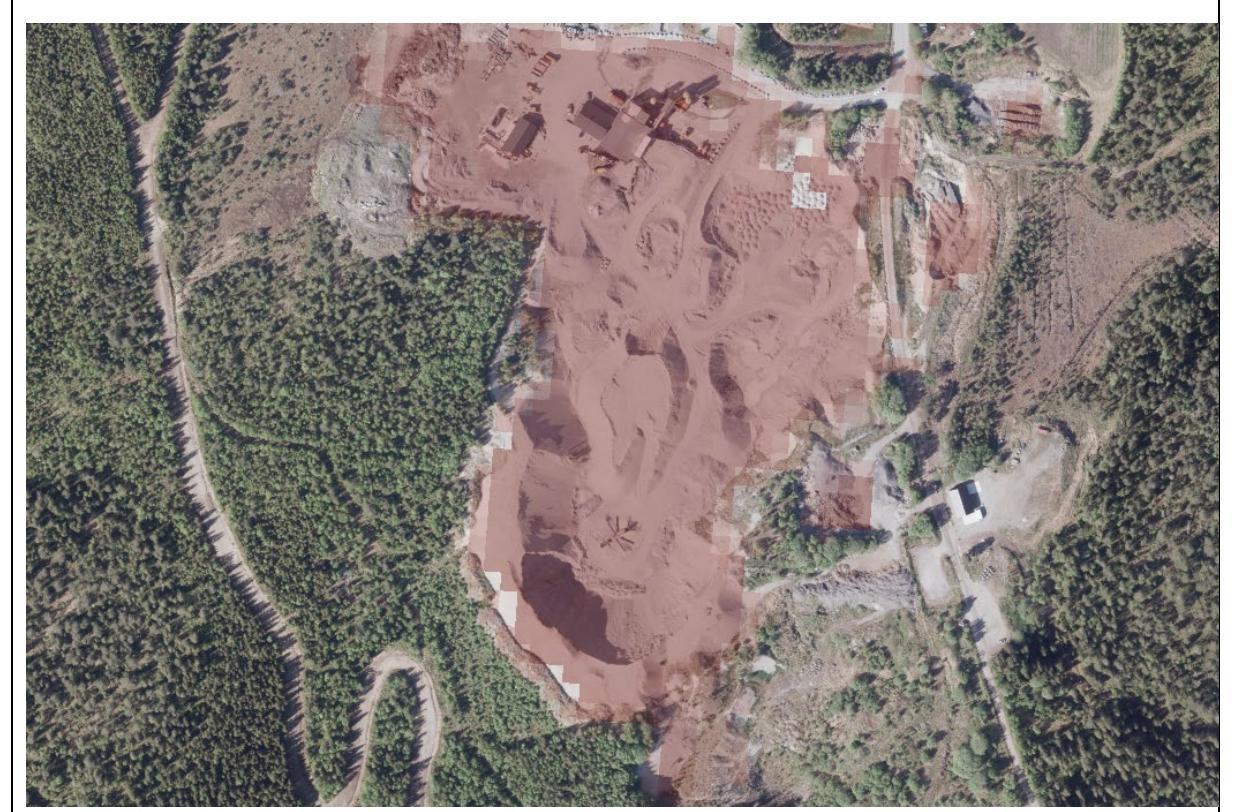
Sand/gravel quarry mistakenly classified as impervious. [ETRS1989 LAEA: 4397800, 4639300]

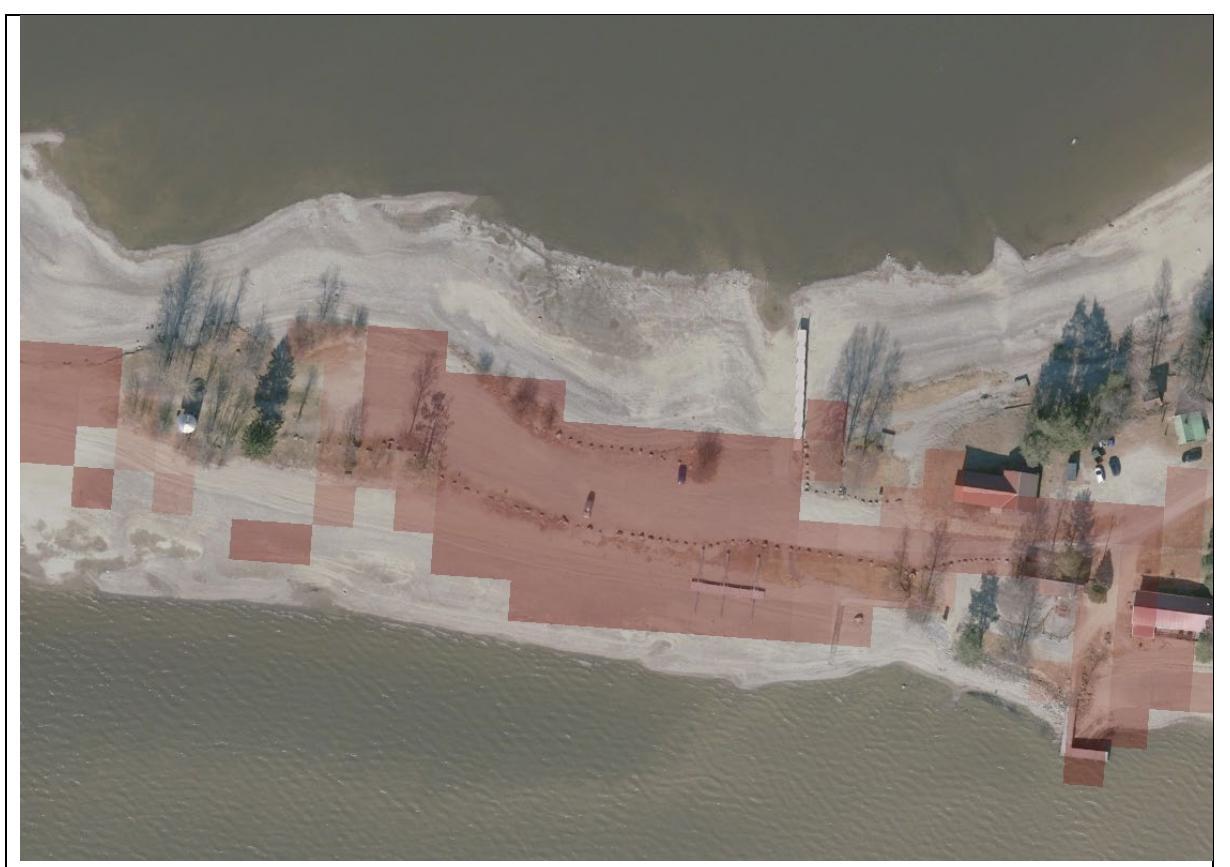
Gravel of a parking lot and the shore of a lake mistakenly classified as impervious. [ETRS1989 LAEA: 4391483, 4063727]

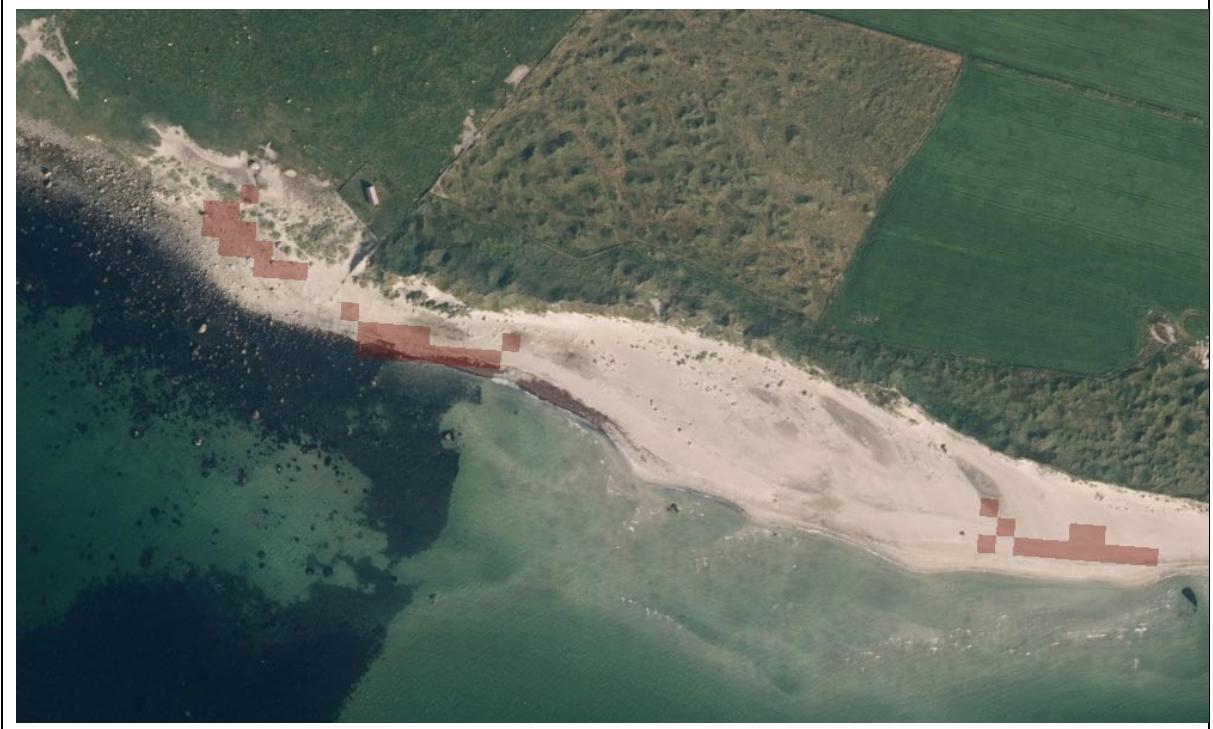
Sand beach partially classified as impervious. [ETRS1989 LAEA: 4070220, 3944800]

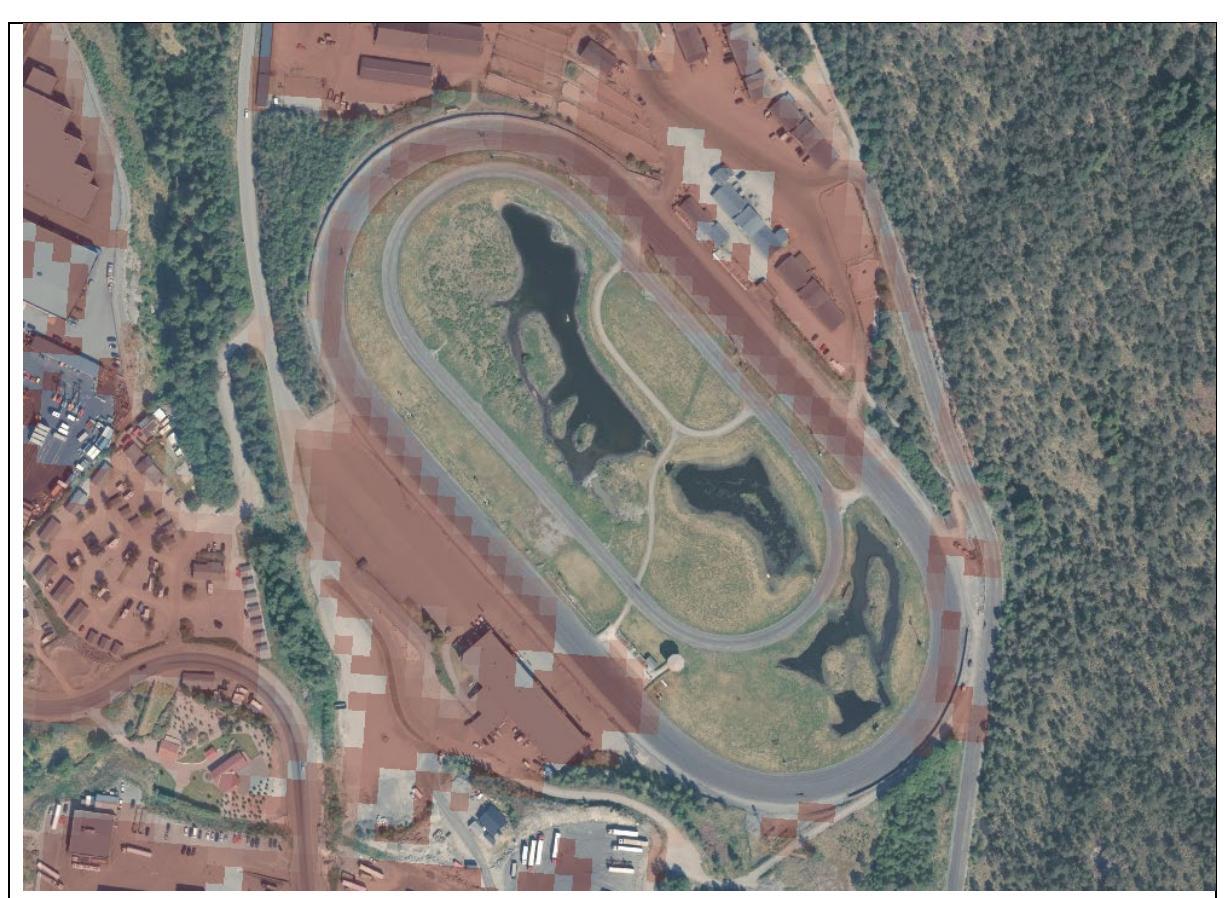
A horse racecourse. Not sure what it is covered with, but sand or fine gravel might be. Classification was a bit indecisive. [ETRS1989 LAEA: 4066800, 4162200]

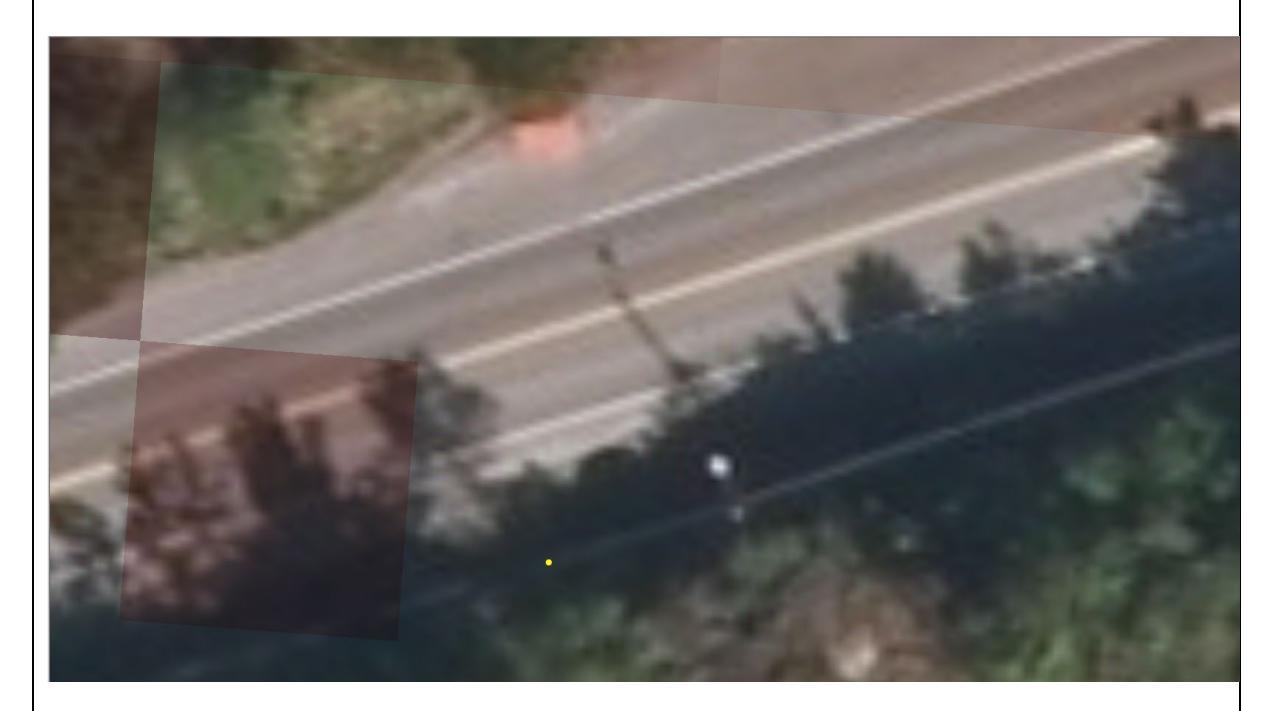
Hard surface road. Only parts are mapped as imperviousness > 0. [ETRS1989 LAEA: 4303100, 3993700]

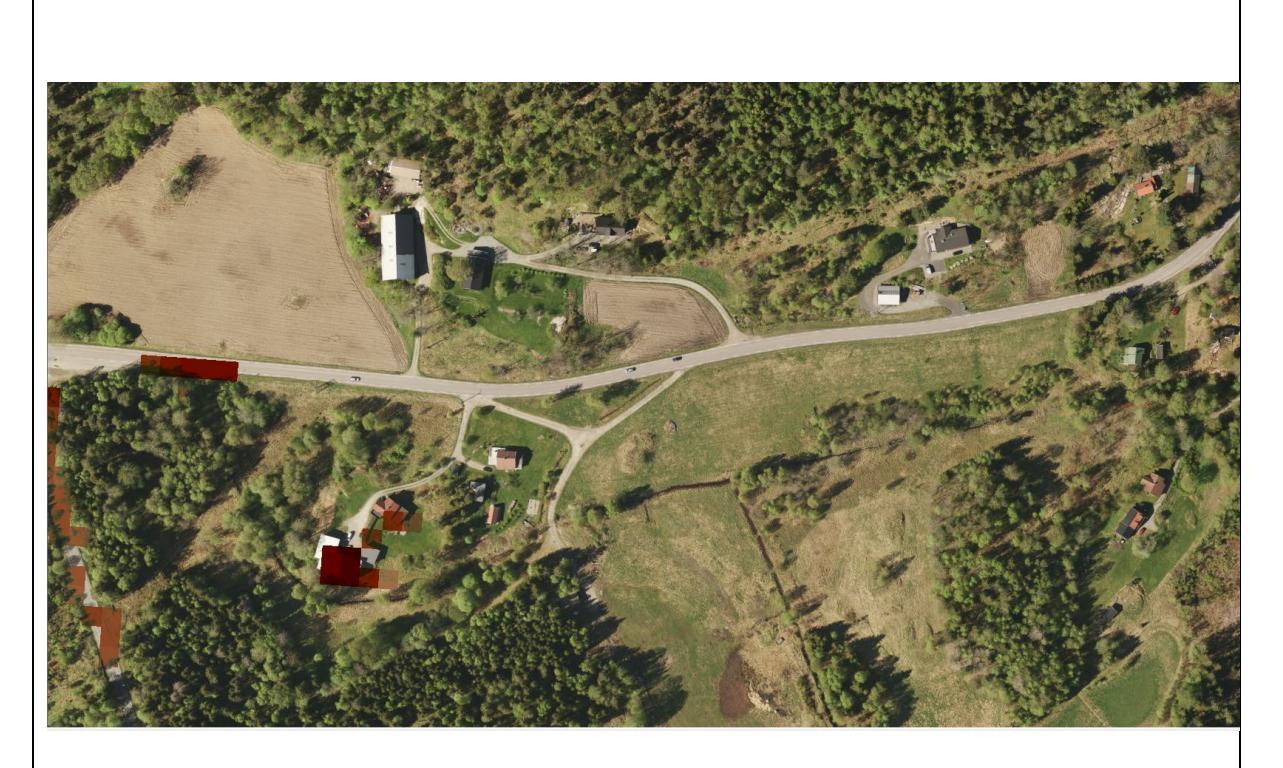
Highway and, farms and rural buildings. Most of the impervious areas are mapped with imperviousness = 0. [ETRS1989 LAEA: 4357100, 4077300]

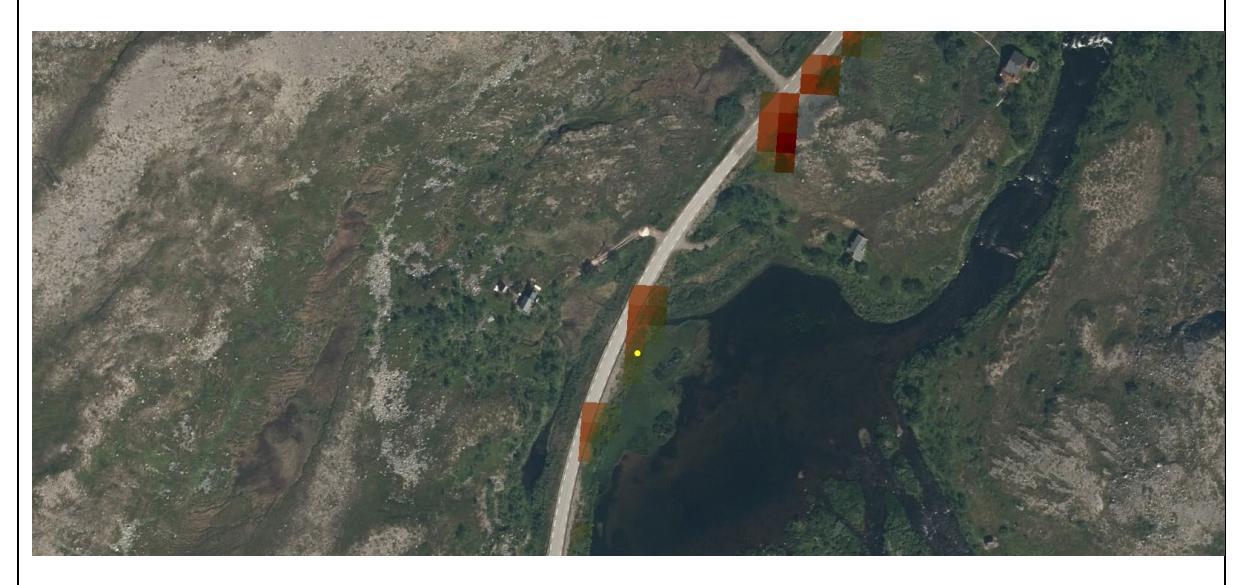
Highway. Only patches are mapped as imperviousness > 0. These patches are also mapped slightly off the actual road (geometrical inaccuracies). The pixel with the yellow dot at the centre of the image has imperviousness = 22 % (Class = 1) but is outside the road. It is still evaluated as "correct" since the distance to the road is short and there are pixels in the immediate vicinity where Class = 1 is a correct label

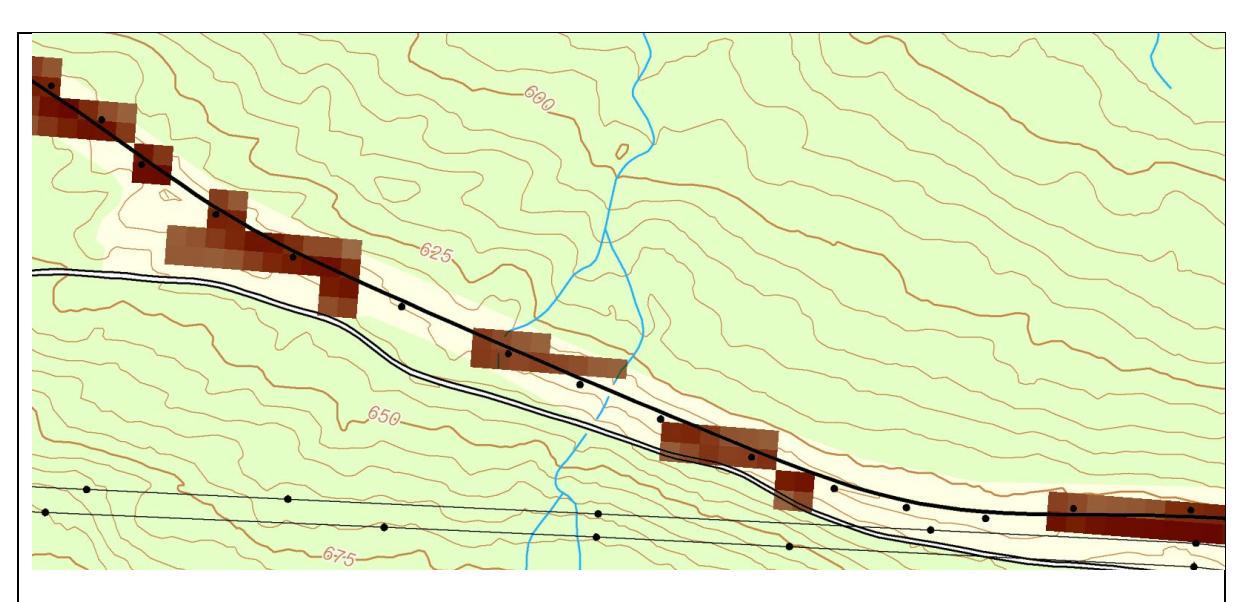
Railway line partially classified as impervious. Same situation as in IMD-2015, where the line also was represented as patches of impervious land. Notice that the road south of the railway line is a gravel road, and correctly mapped as not impervious. [ETRS1989 LAEA: 4229600, 4165250]

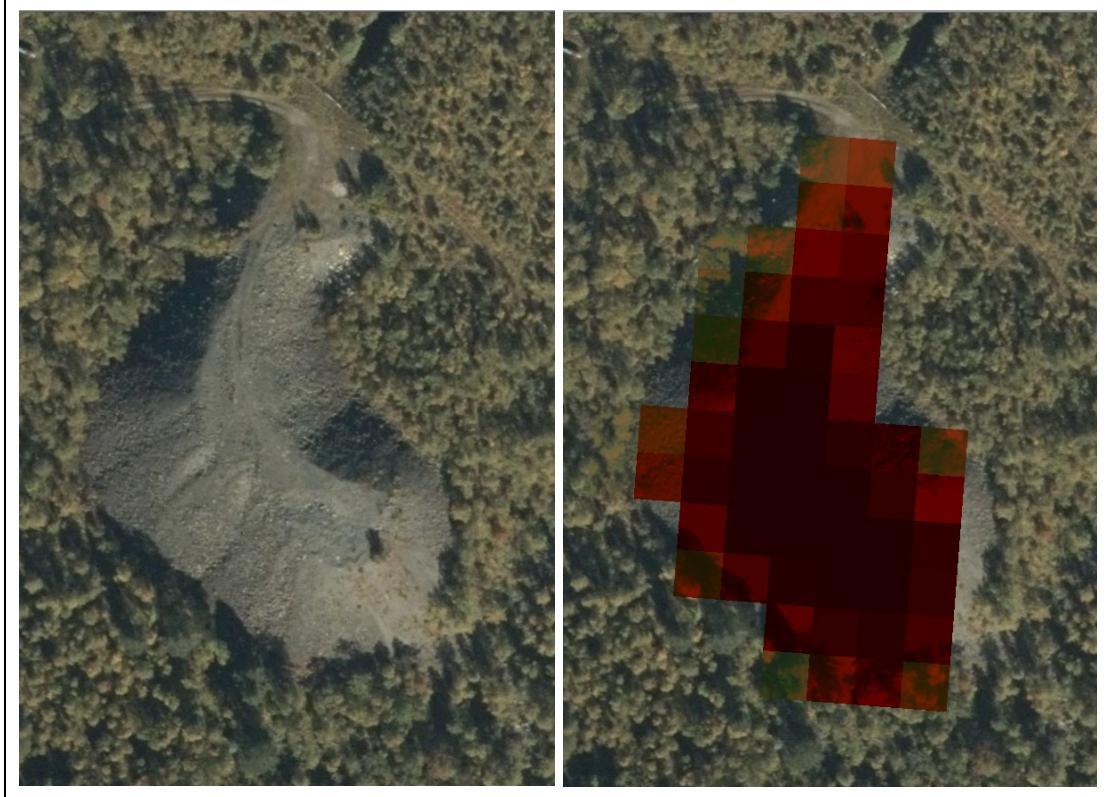
A large rock and gravel deposit (from tunnel dug as part of a hydropower development in 1955) at [ETRS1989 LAEA: 4171900,] that was wrongly mapped as impervious in IMD-2015 is now corrected. The entire dumpsite is mapped as IMD=0 in 2018. Another rock deposit from the same hydropower development, but 1,5 km further east, is still mapped as impervious (aerial photo with and without IMD-layer superimposed) [ETRS1989 LAEA:4219550, 4171700]

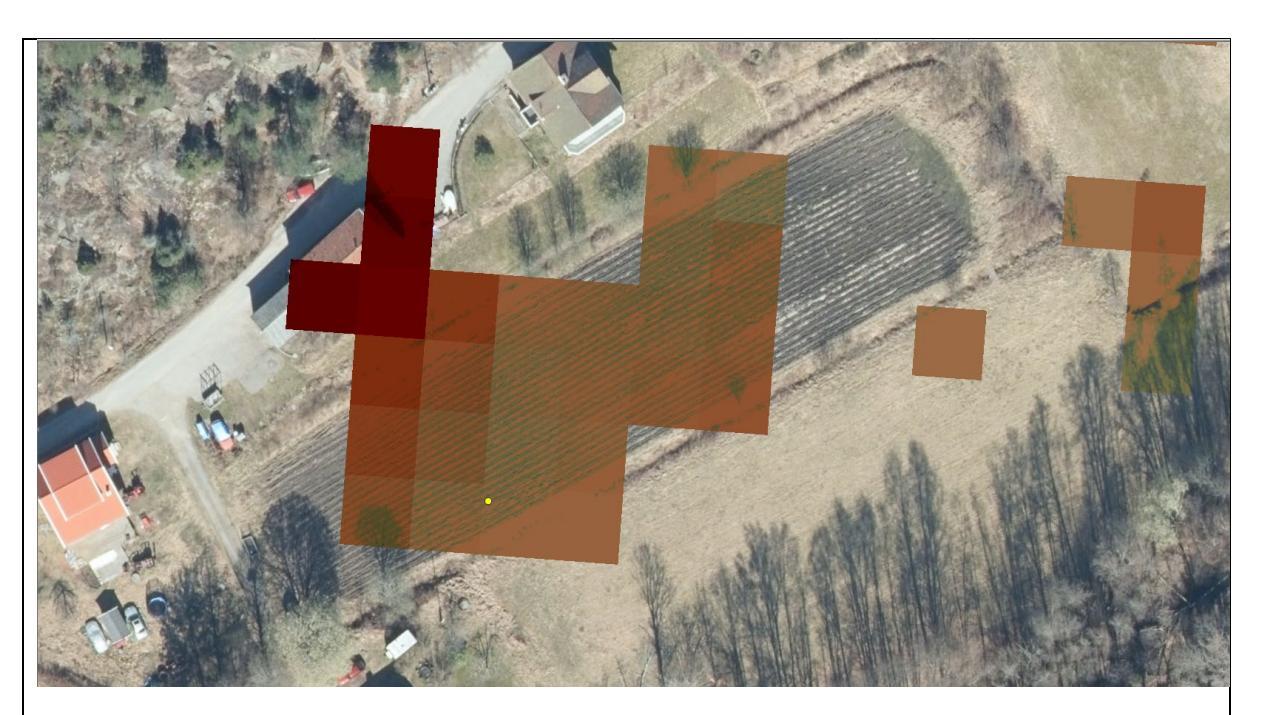
Agricultural field planted with row culture and mapped as impervious. Could have been covered with plastic in the satellite image? [ETRS1989 LAEA: 4403850, 3990400]

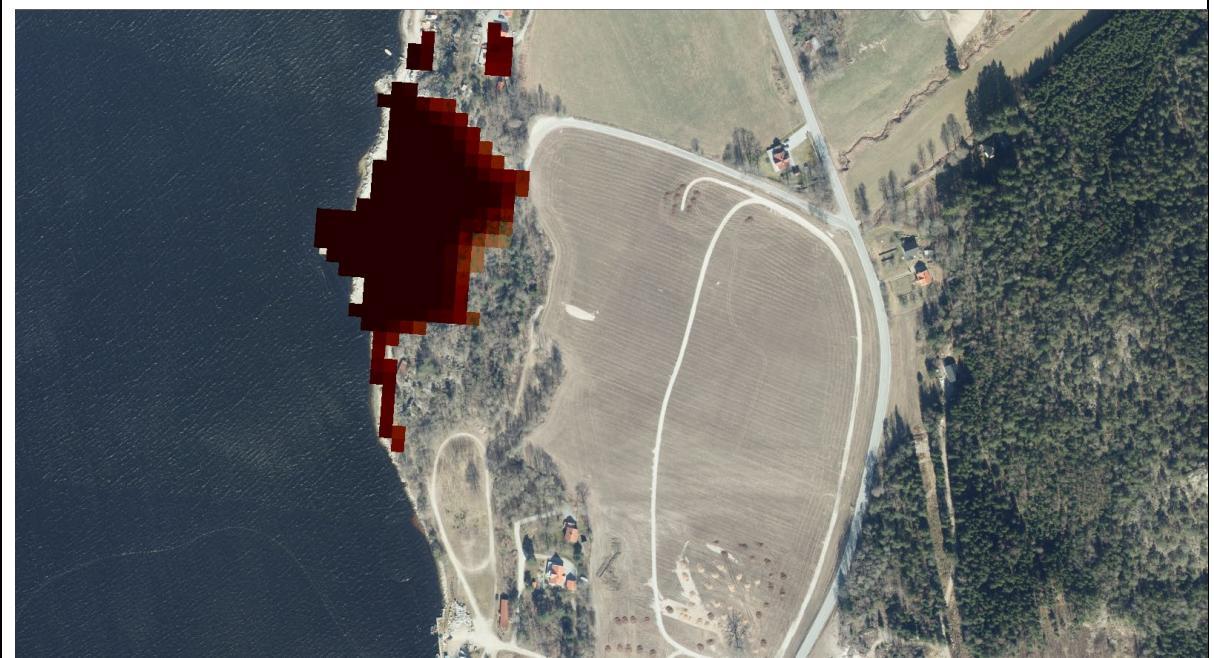
Quarry wrongly mapped as impervious [ETRS1989 LAEA: 4404070, 3991940]

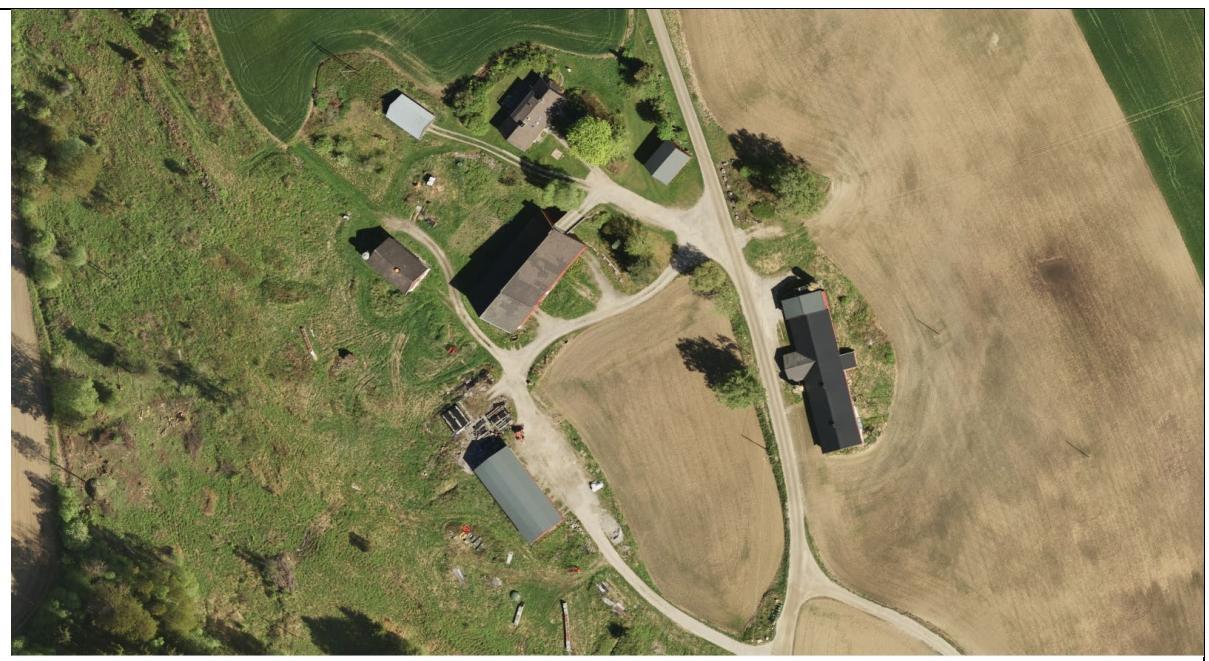
Buildings in an otherwise agricultural area, not classified as impervious. [ETRS1989 LAEA: 4381275, 4071243]

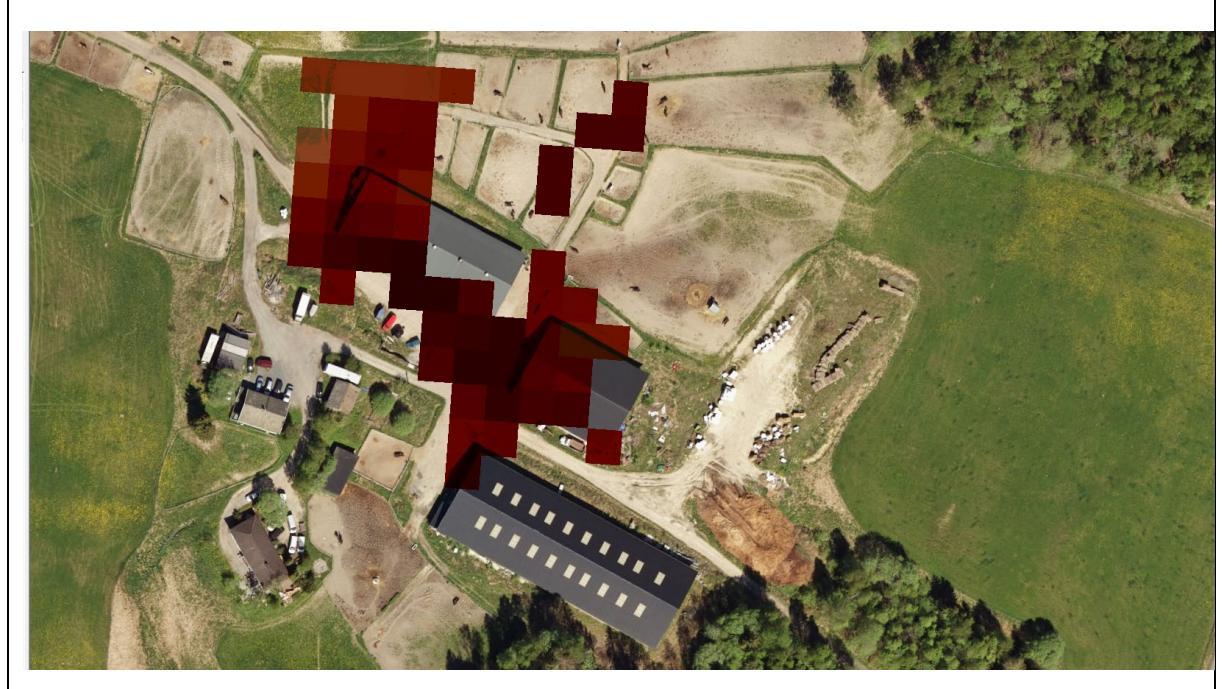
Stables with paddocks. In 2015, the upper left stable and some of the paddocks were classified at impervious. These still classified as impervious in 2018, and the second stable (center of the image) is added to the impervious area. The large riding house at the bottom is not classified as impervious (and was not in 2015 either). It is present on aerial imagery from 2011 and was probably built in 2009 or 2010. [ETRS1989 LAEA: 4388915, 4104625]

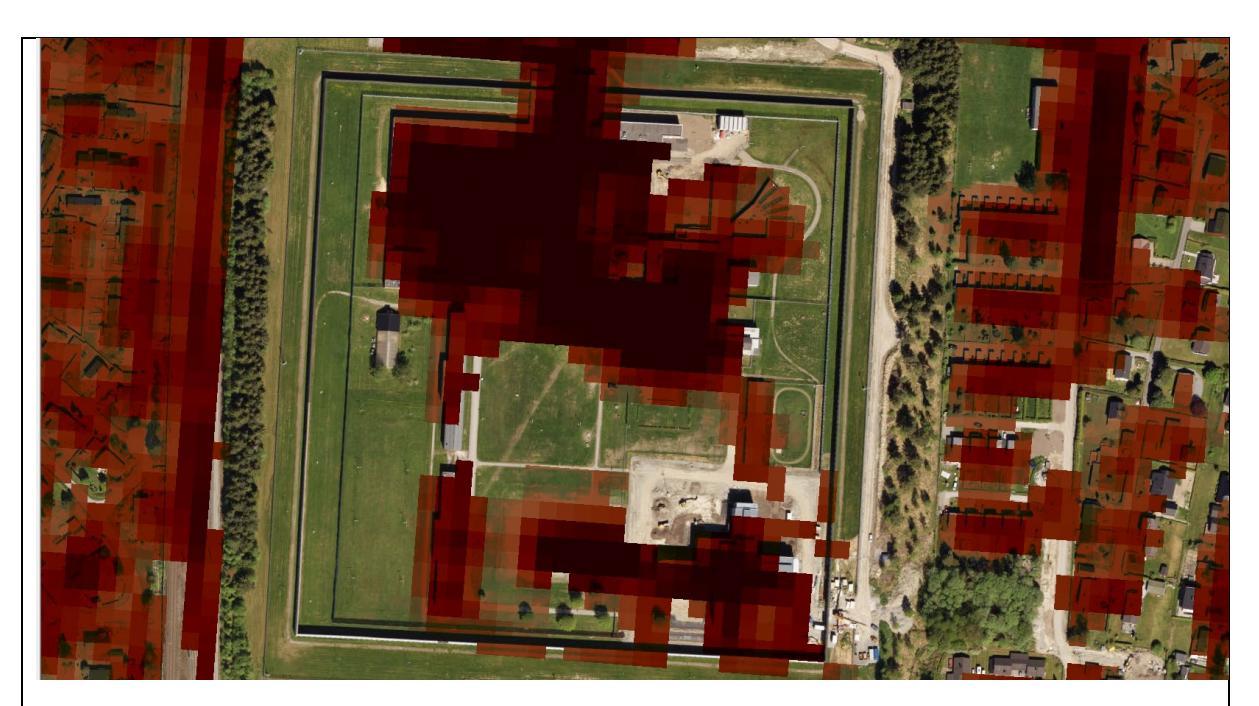
Prison. The representation of the impervious buildings surrounded by open green areas is quite accurate. Also notice the fairly accurate representation of the town houses in the neighbourhood on the left. [ETRS1989 LAEA: 4384906, 4108267]

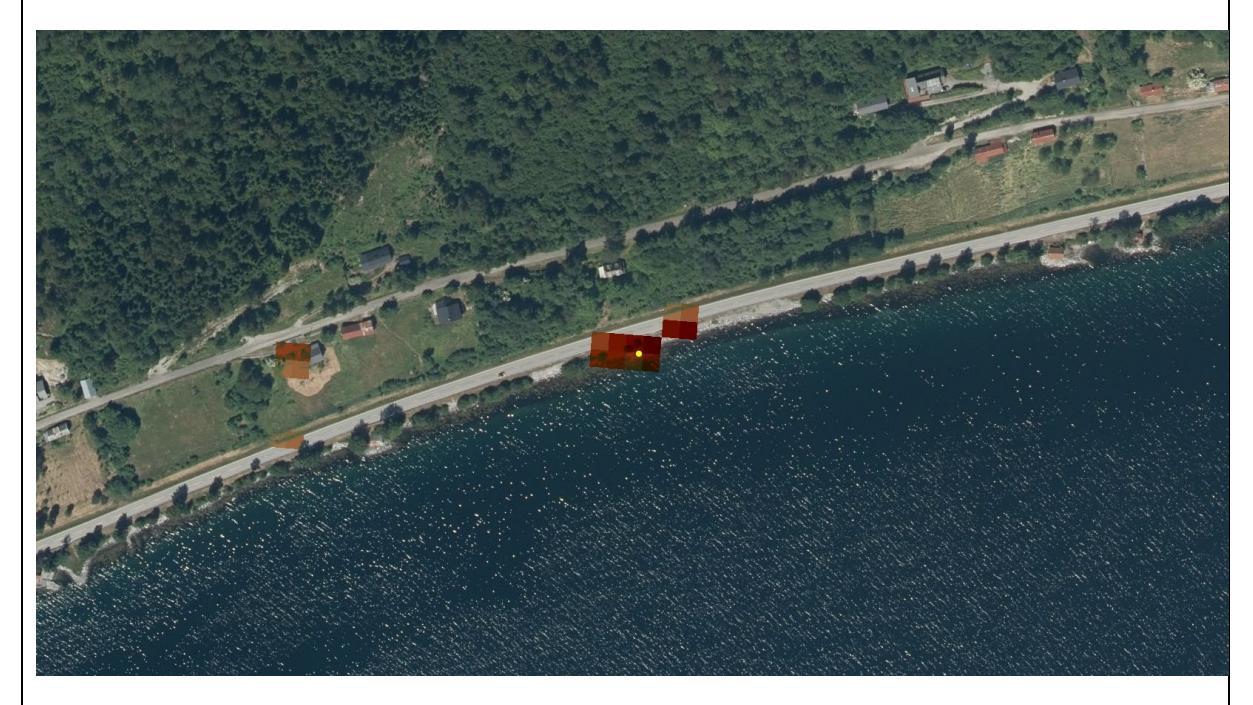
Highway and scattered settlements along Isfjorden. Only a few pixels are shown as partly impervious. [ETRS1989 LAEA: 4201257, 4388284]

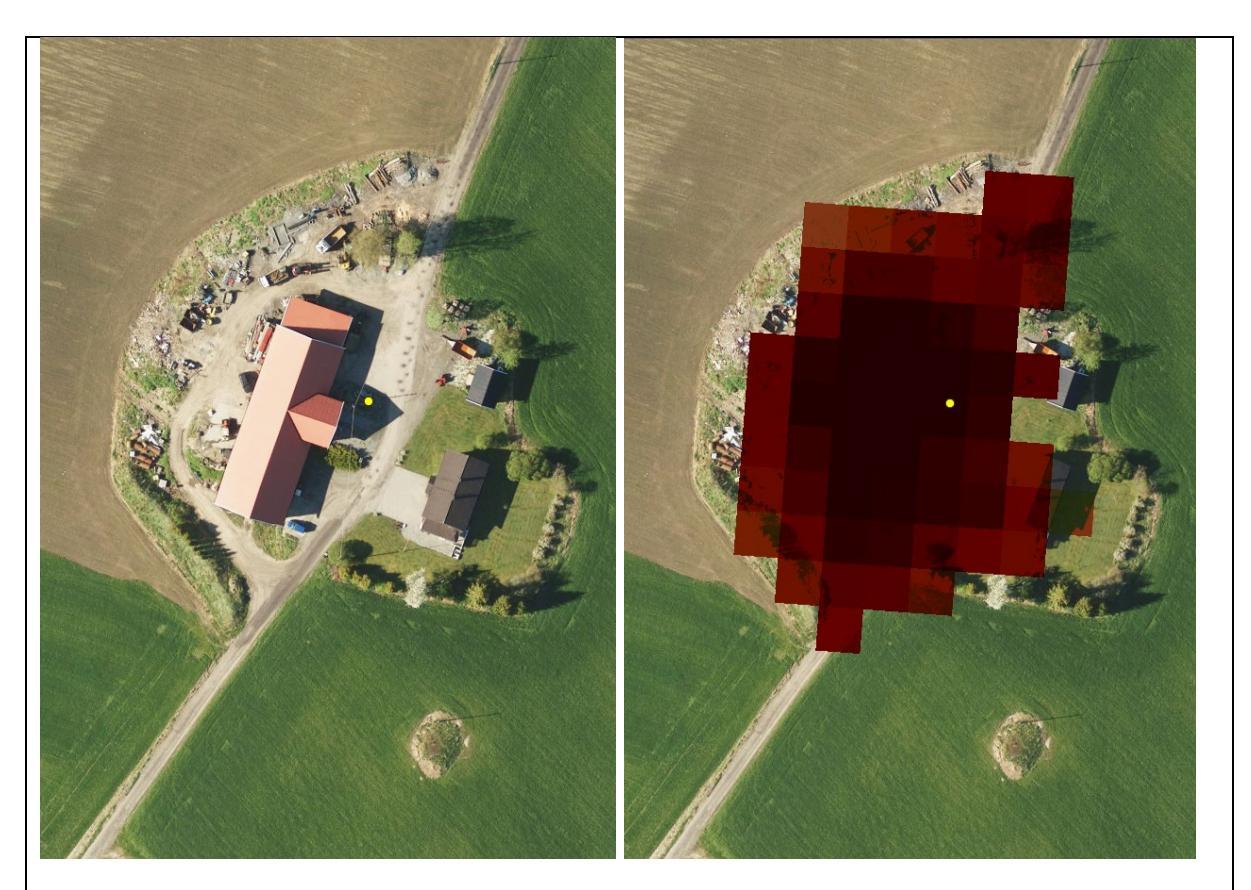
Farmstead with house, garage and a large barn mapped as impervious. Farm equipment parked around the barn may have been interpreted as additional imperviousness? [ETRS1989 LAEA: 4372652, 4069653]

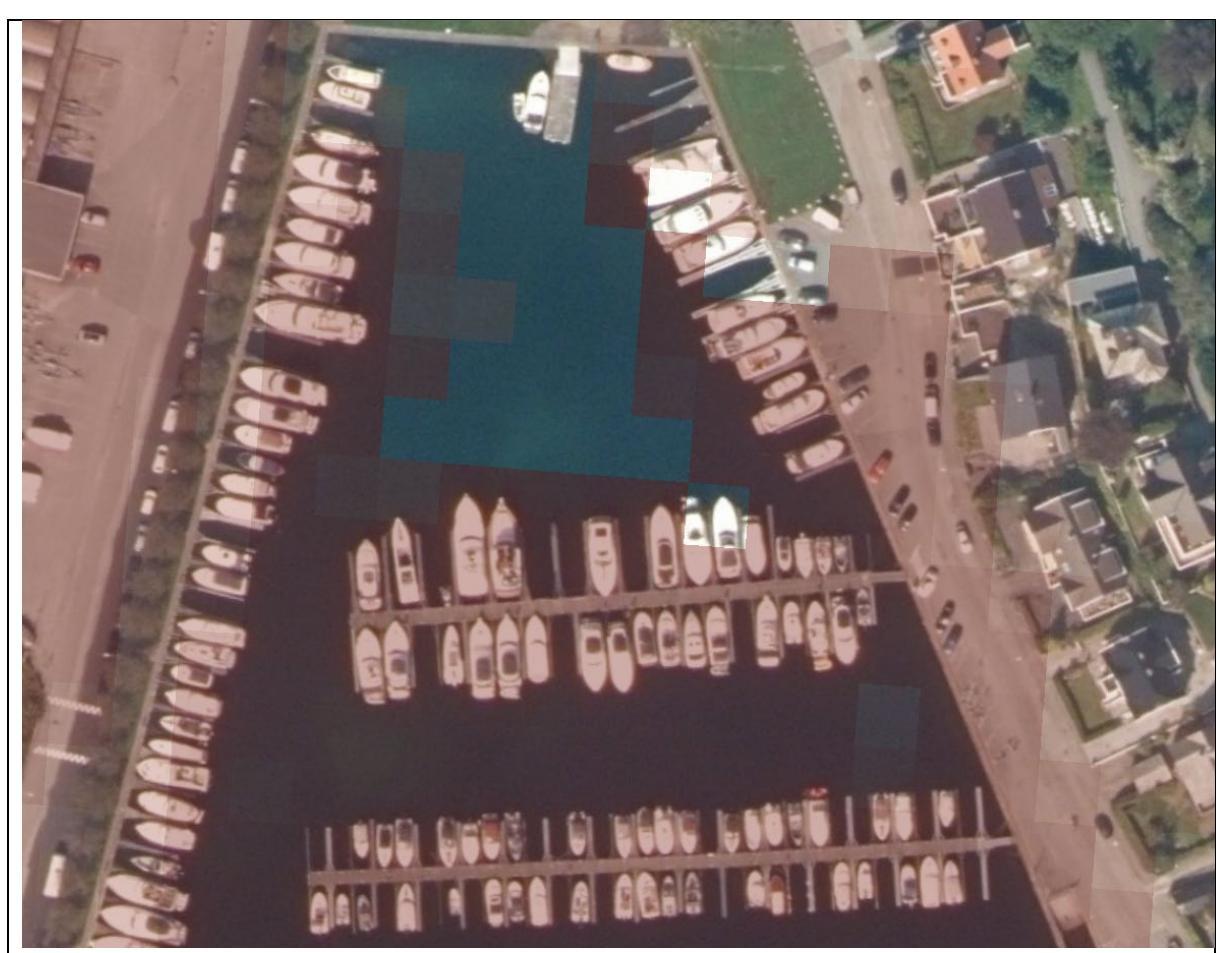
Fun fact: leisure boats in a marina classified as impervious. While technically indeed manmade blocking rainwater from drainage, problably not the first thing that comes into your mind. [ETRS1989 LAEA: -4075869, 3991697]

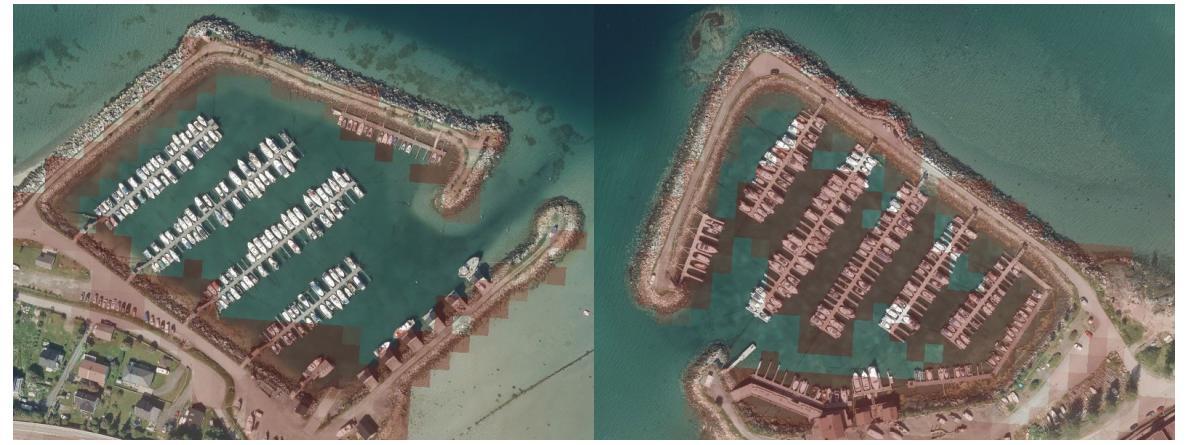
Two Marinas in Narvik, four kilometers from each other. While in one boats were classified as non-impervious, in the other they were not. In both marinas boats are visible on 28.7.2018-Sentinel-2-scenes. Left: [ETRS1989 LAEA: 4625550, 5049688] – right: [ETRS1989 LAEA: 4628300, 5052470]

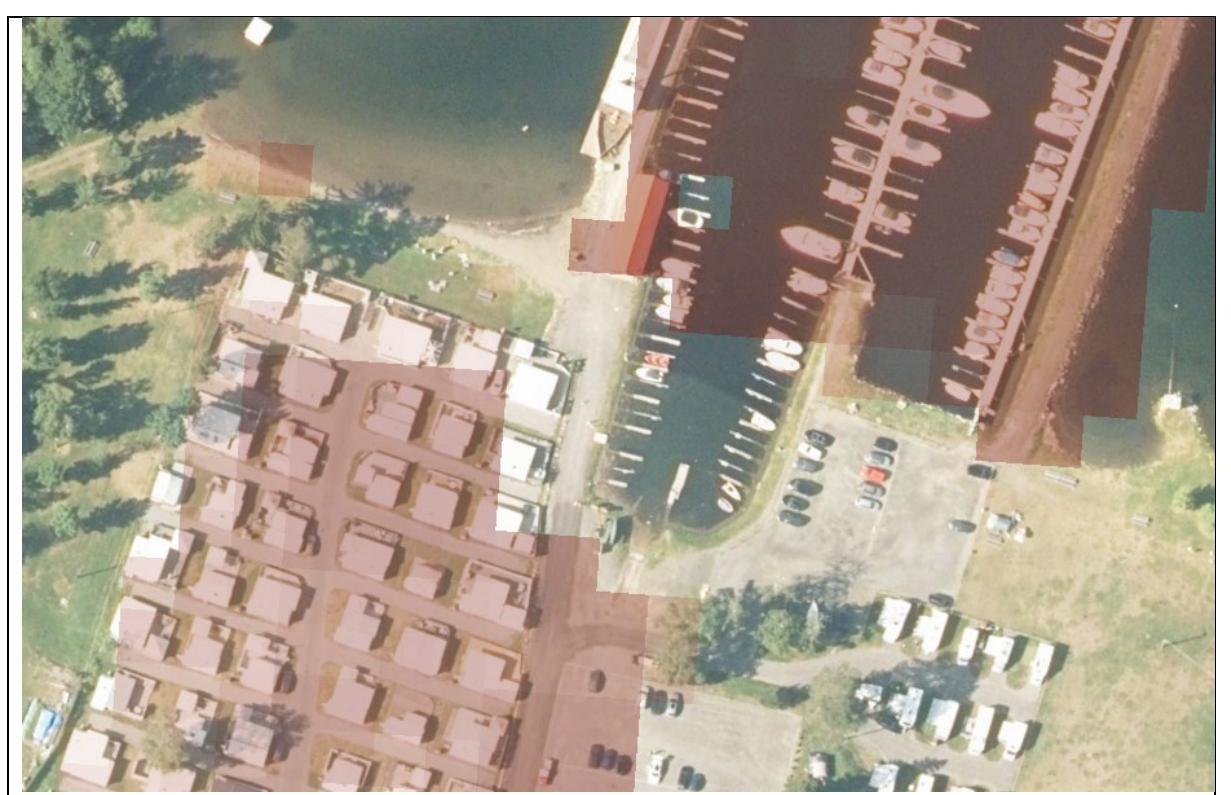
Marina and caravan park with paved access roads and few greens at a lake, both considered impervious. [ETRS1989 LAEA: 4378390, 4171820]

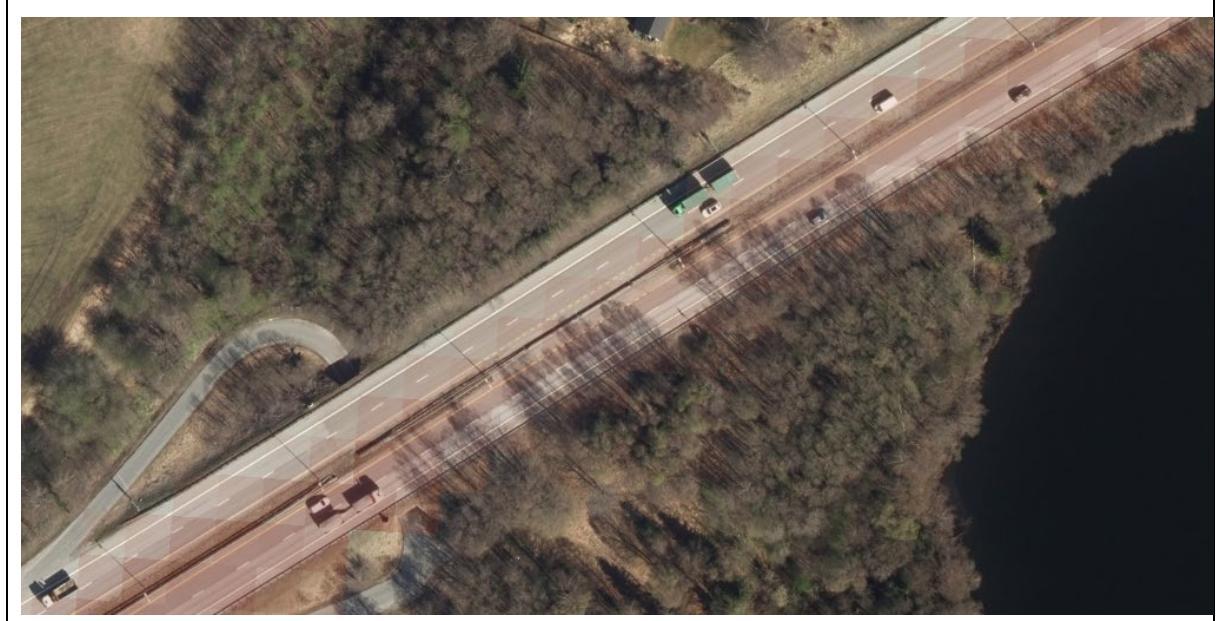
Shadows may impact the quality of detecting highways or other impervious surfaces. [ETRS1989 LAEA: 4340777, 4080251]

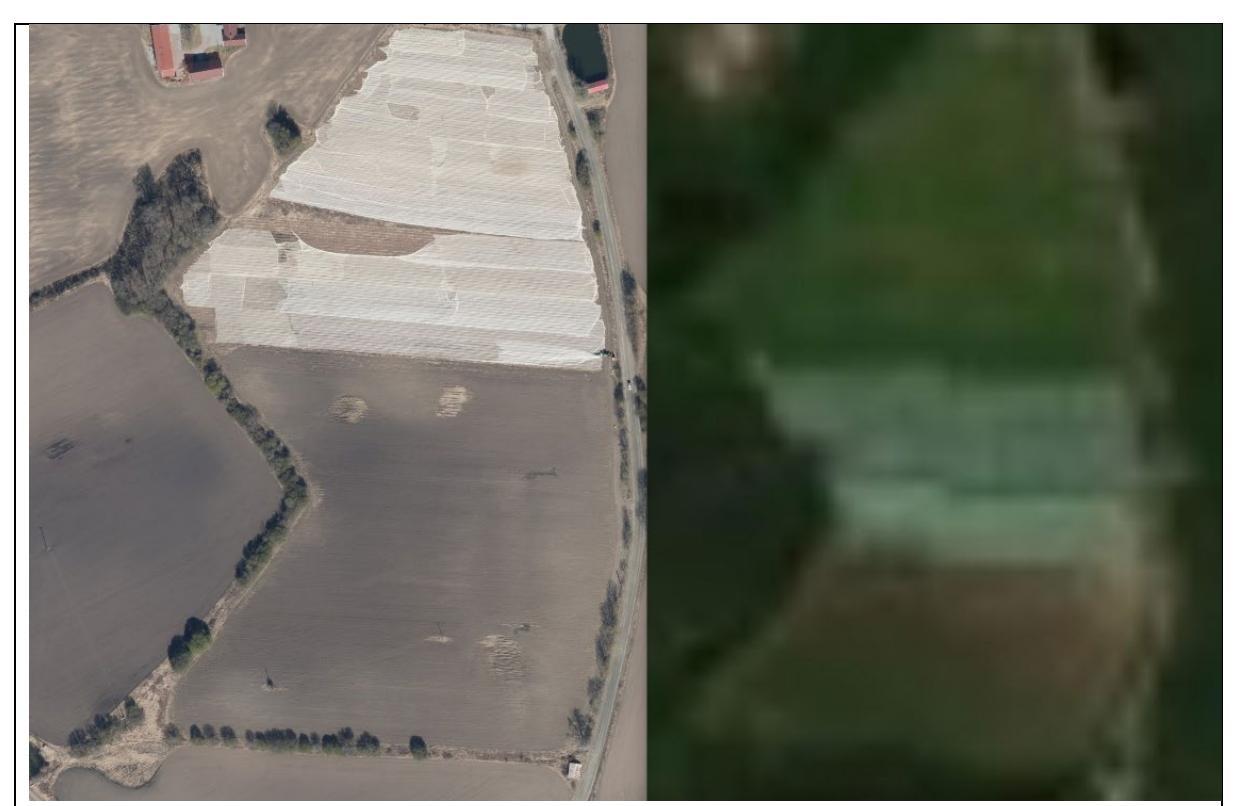
To the right, the middle part of a field suspected to be covered with plastic, and correctly not classified as imperveous as they are seasonal. Right: Sentinel-2, 8.7.2018; left: Ortophoto 29.5.2020 used for control. [ETRS1989 LAEA: 4184130]
