HRL 2018 look & feel verification report for Imperviousness (2018) Norway

I. Administrative part

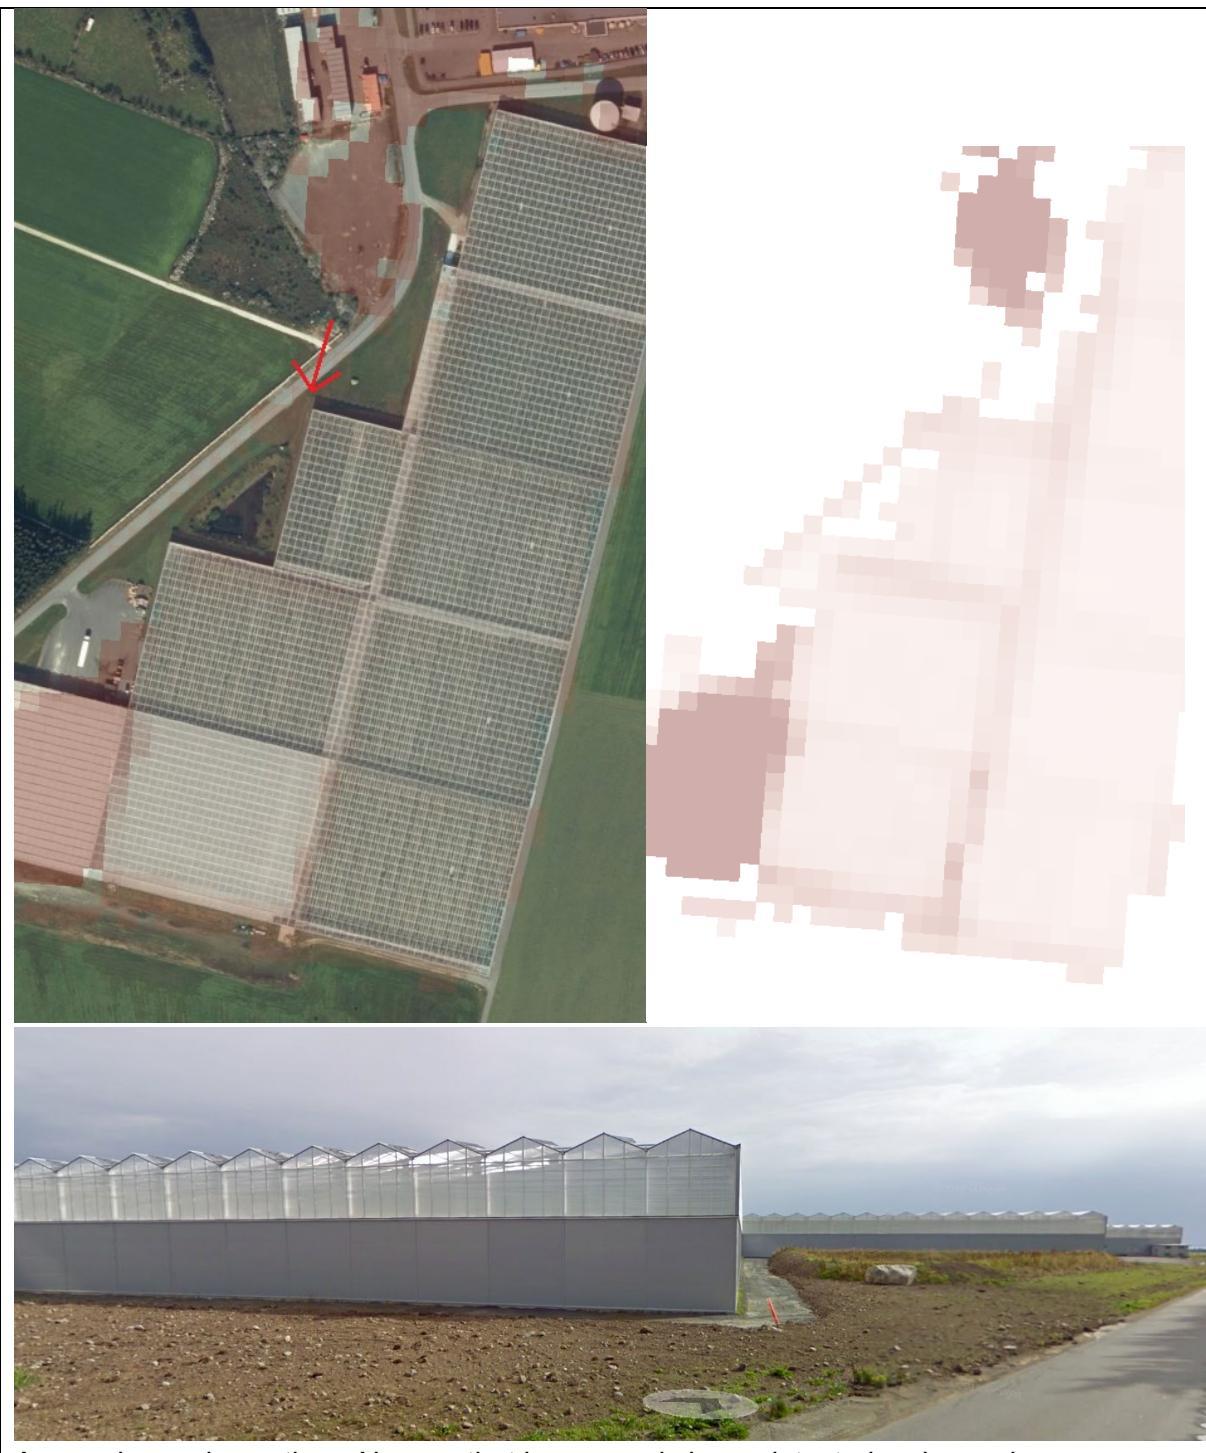
A greenhouse in southern Norway that has vaguely been detected as impervious. [ETRS1989 LAEA: 4066850, 3956400]
