HRL 2018 look & feel verification report for Imperviousness (2018) Norway

I. Administrative part

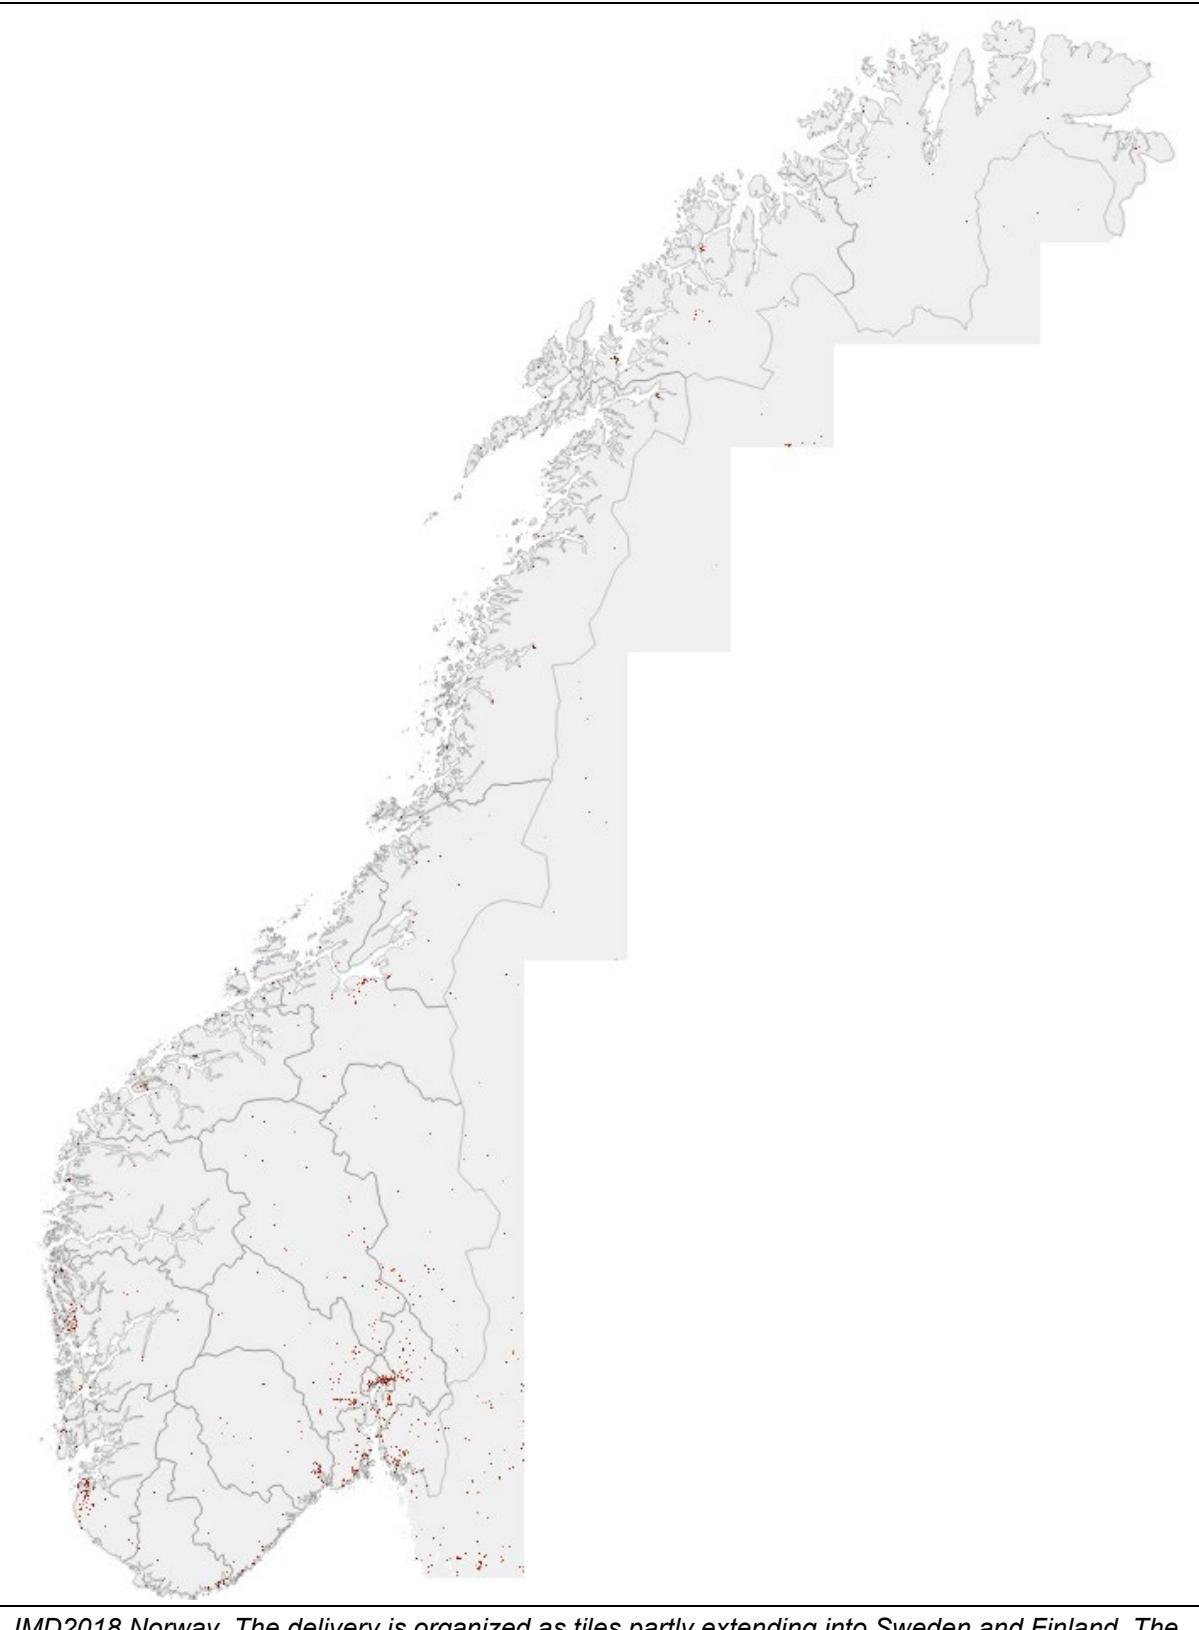
IMD2018 Norway. The delivery is organized as tiles partly extending into Sweden and Finland. The verification is limited to areas inside Norway.
