HRL 2018 look & feel verification report for Tree Cover density (2018) Norway

HRL	Tree Cover Density 2018
Verified area, region	Norway
Institution carrying out the work	NIBIO Survey and statistics
Overall visual checking done by	Karsten Dax, Senior Engineer
(name, position and e-mail)	Karsten.Dax@nibio.no
Look & feel verification done by	Karsten Dax, Senior Engineer
(name, position and e-mail)	Karsten.Dax@nibio.no
In situ data used	National ortophoto database Norge-i-bilder
	Ref: http://www.norgeibilder.no
	National spatial data infrastructure
	Ref: <u>http://kilden.nibio.no</u>
	AR18X18, a Norwegian area frame survey of land cover re-
	sembling LUCAS
	Ortophoto, topographic and thematic maps available as
	wms services were integrated with the HRL data using qGIS
Reporting done by	Karsten Dax, Senior Engineer, Karsten.Dax@nibio.no
(name, position and e-mail)	Geir-H Strand, Director R&D, ghs@nibio.no
Date and place of writing the report	Ås 26.03.2021

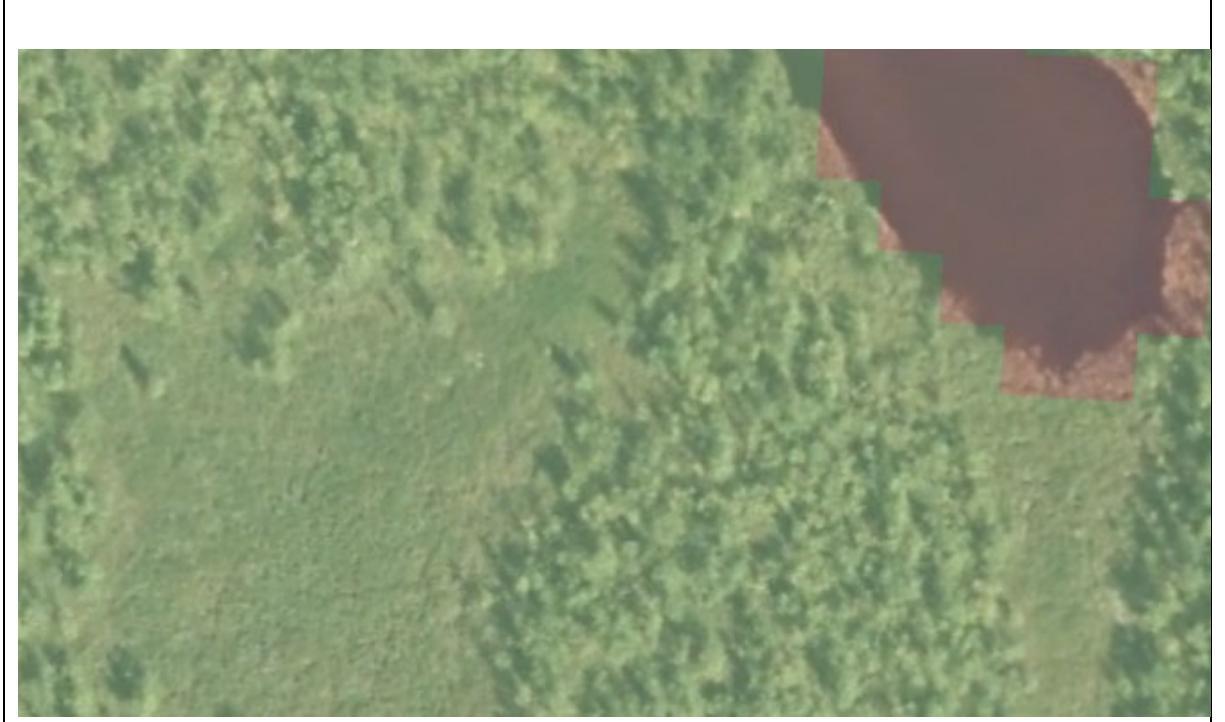
Northern Norway (Finnmark), inland: Dense forest (green) and no forest (lake, red) classified correctly, while the clearings are not classified as no forest. [4913811,5221959]

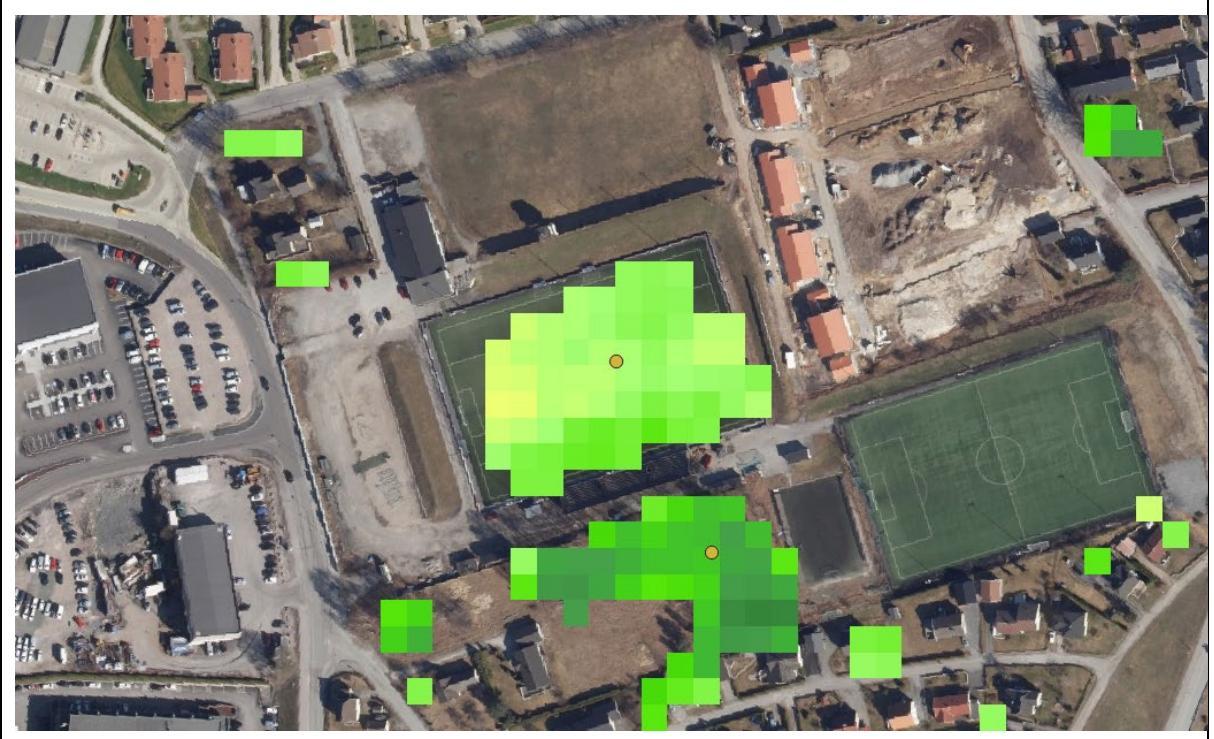
A soccer field (center) wrongly mapped as tree-cover (The lower patch is a recreational area correctly mapped with tree cover [4300188, 4005926]

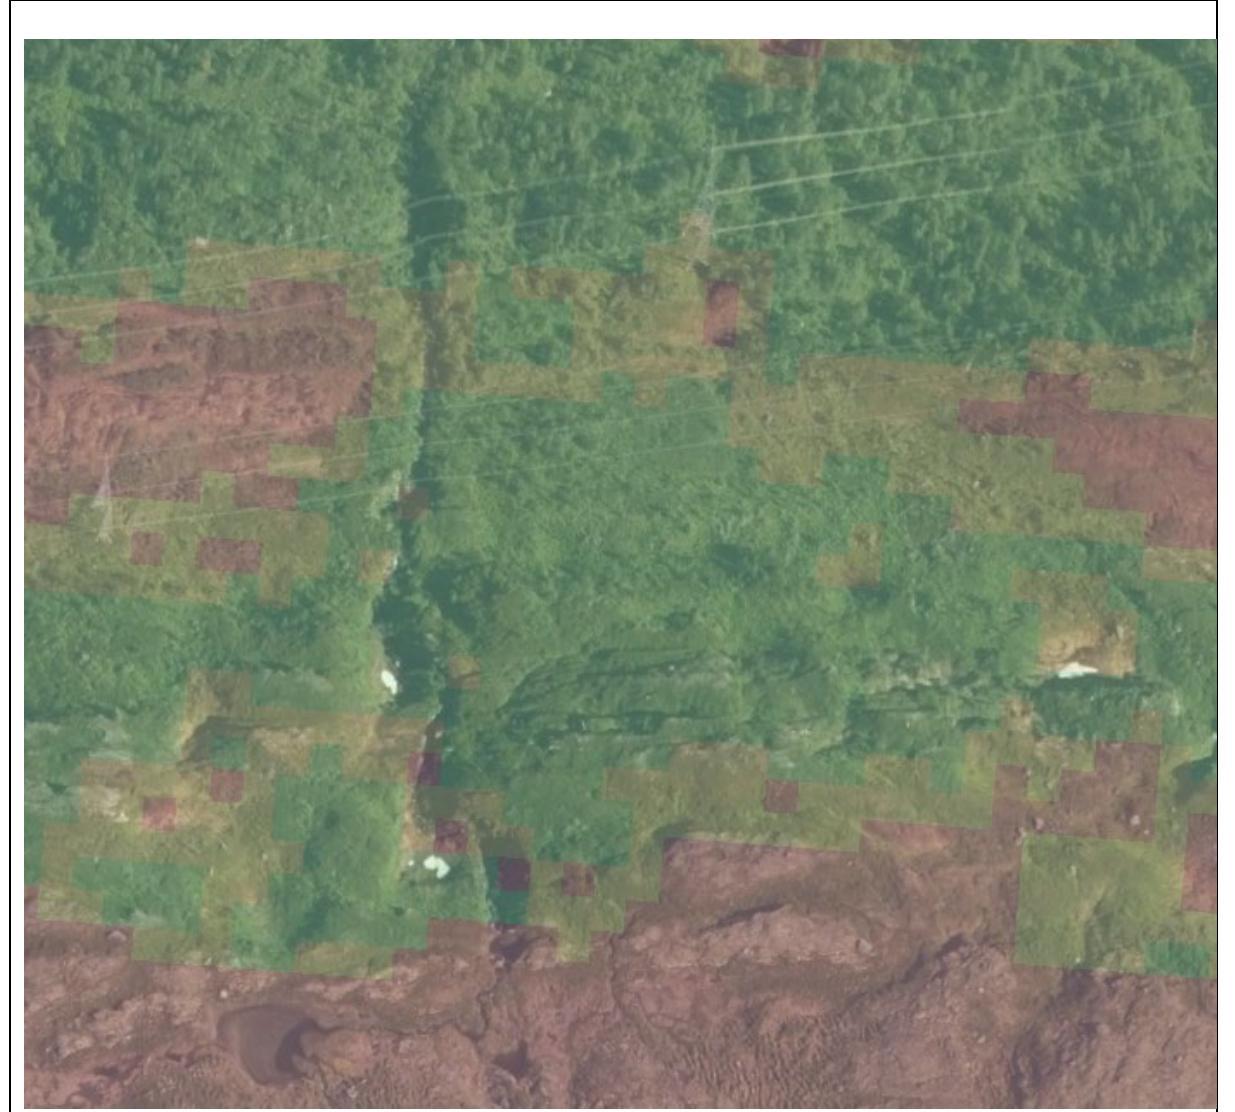
Middle-Norway (Trøndelag), inland. The northern strip of forest is correctly classified as forest (green), and the southern strip has indeed no tree cover (red), while the green band inbetween should be no tree cover in the south and slight tree cover in the north. [UTM33: 4273658, 4433900]

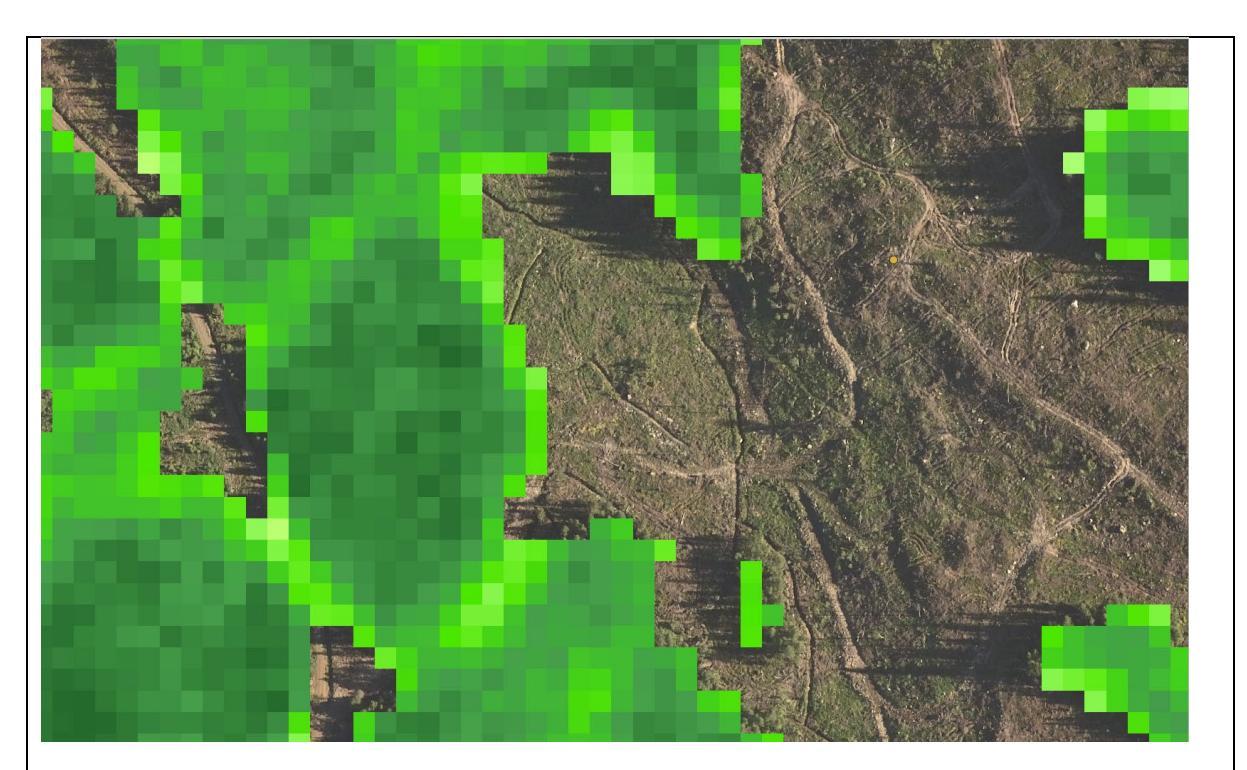
Recent clear cutting correctly mapped as no tree cover [4421135, 4222700]

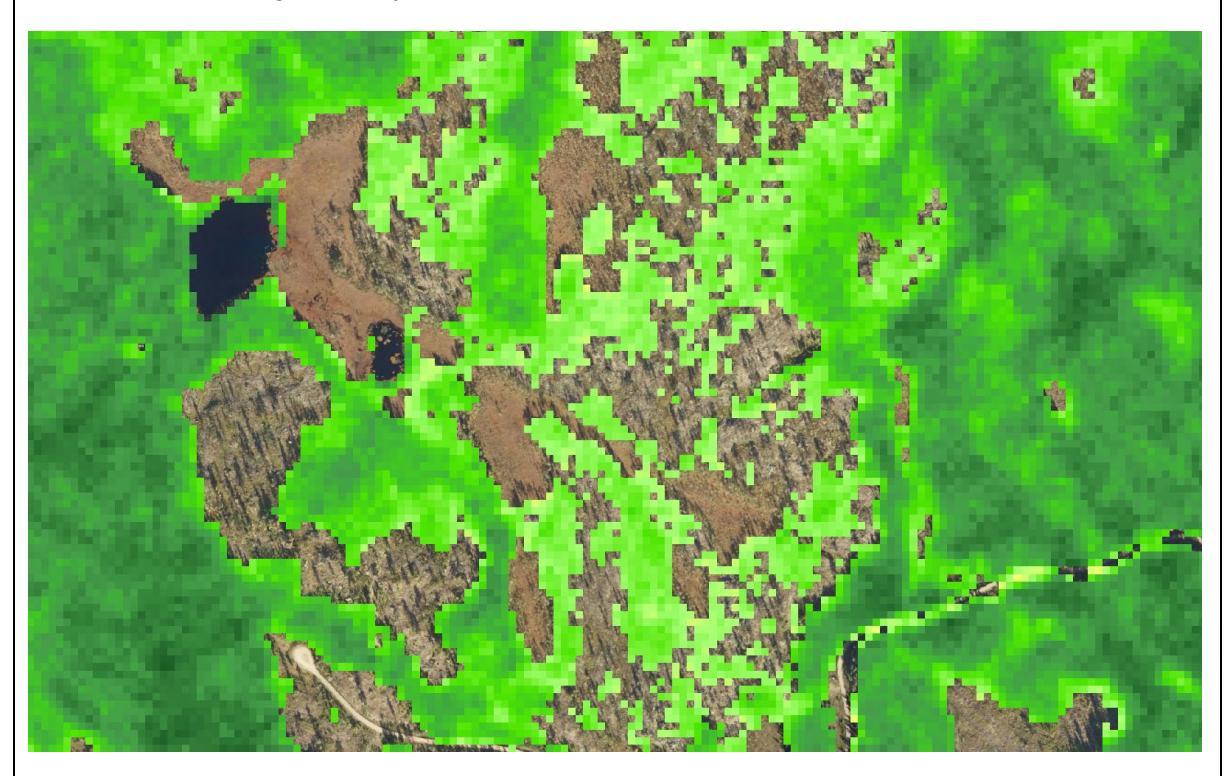
Burnt area (2006). A fen in the center is correctly left as TCD = 0, but the surrounding, burn area has scattered trees and should be mapped with a low TCD > 0. [4399900, 4169470]
